OPERATION REDWING - PROJECT 5.9

WEAPON EFFECTS ON MISSILE STRUCTURES AND MATERIALS (U) SANITIZED VERSION

C. J. Cosenza, Lt, USAF, Project Officer
G. W. Mills
G. J. Roth

Aircraft Laboratory
Wright Air Development Center
Wright-Patterson Air Force Base
Dayton, Ohio

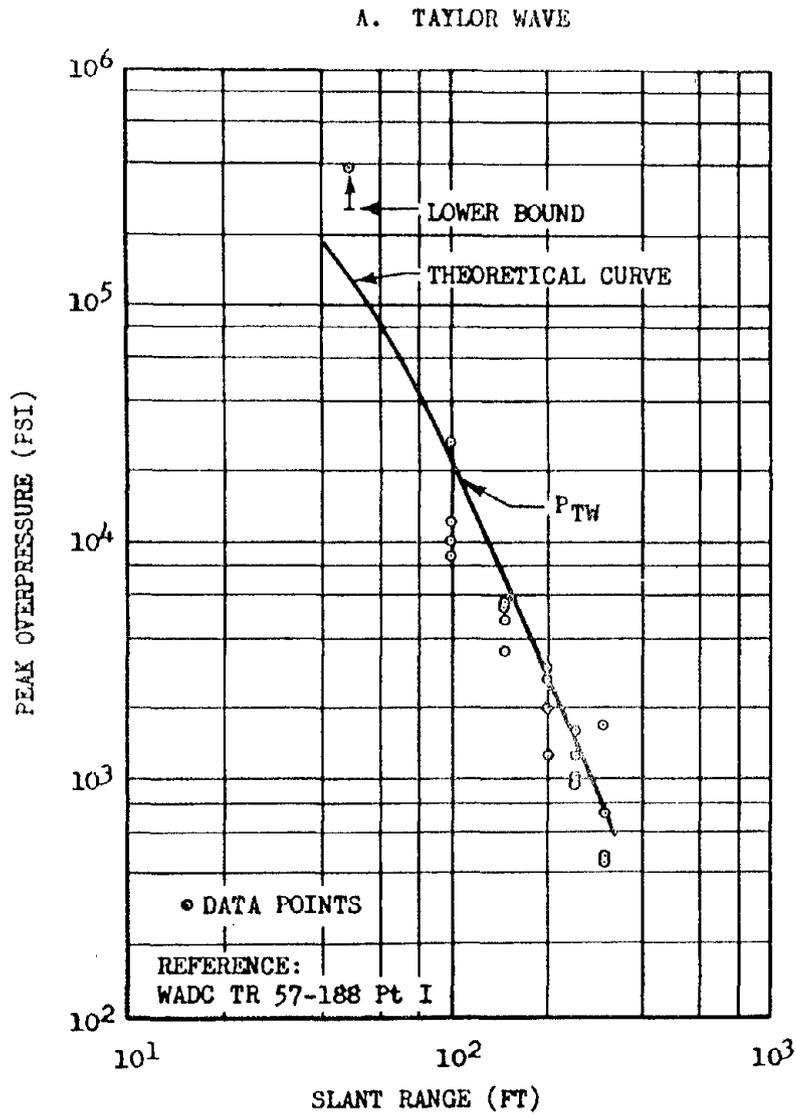
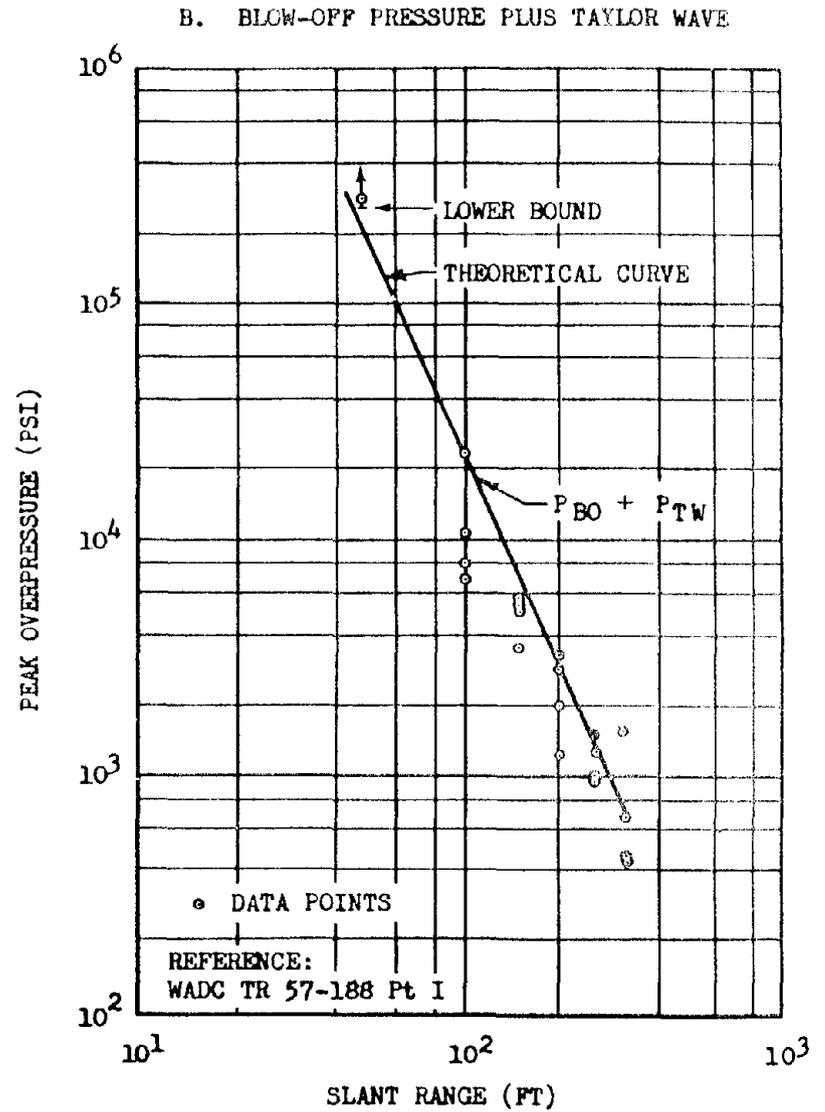
Figure D.7 Observed peak pressure versus slant range.

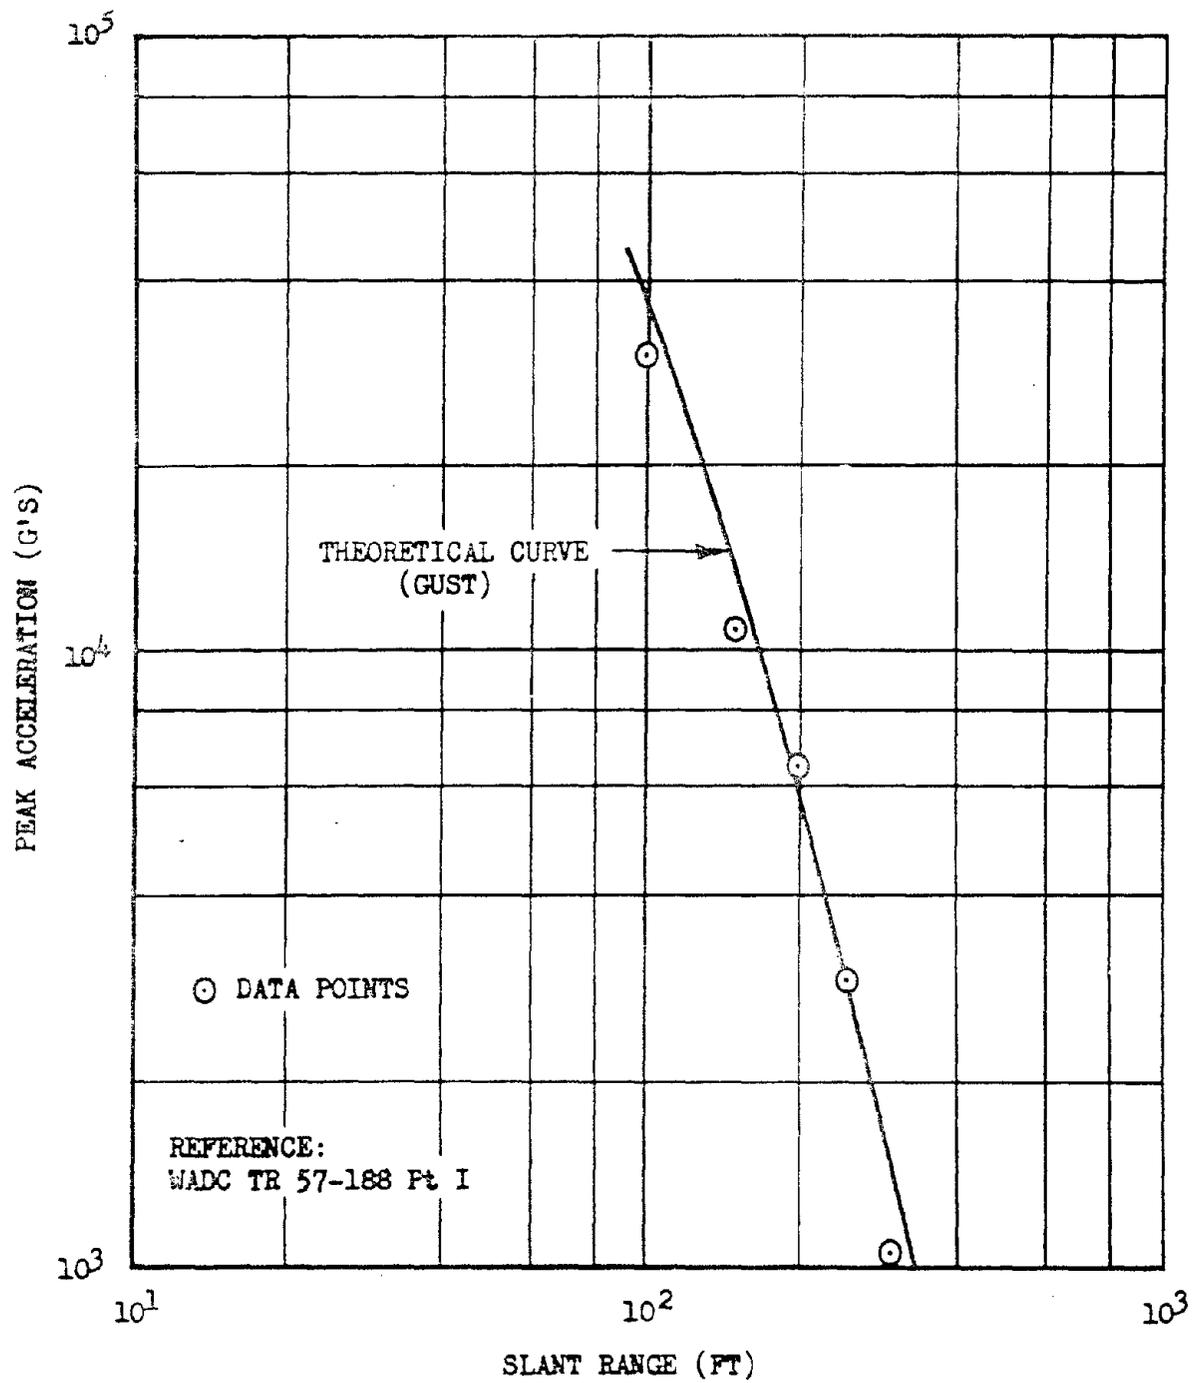
Figure D.8 Observed peak acceleration versus slant range.
